## PHOTO EVIDENCE — FULL TRUSS SYSTEM AND EAST/STAGE-SIDE CEILING CONCENTRATION — PAGE 3 OF 5

## PHOTO EVIDENCE — PLENUM-SIDE CEILING PENETRATIONS AND DAMAGED LATH

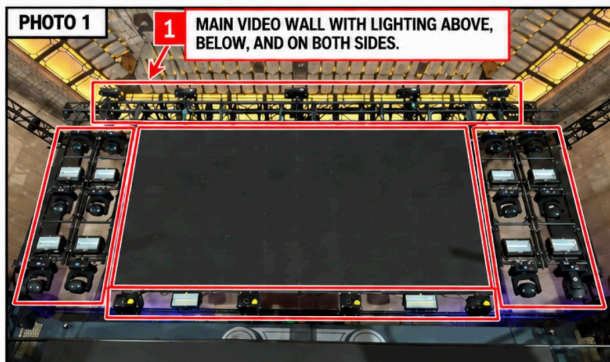
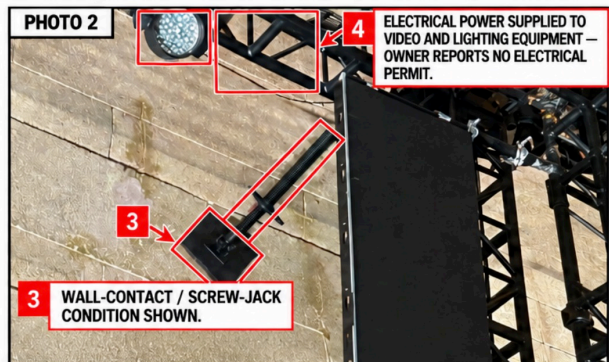
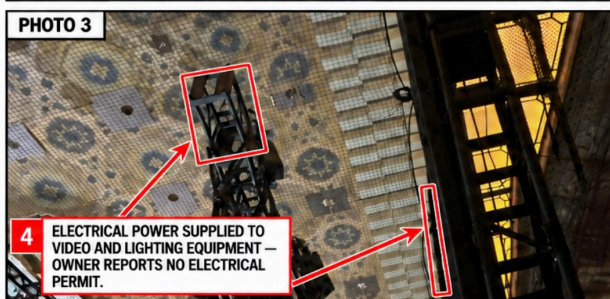
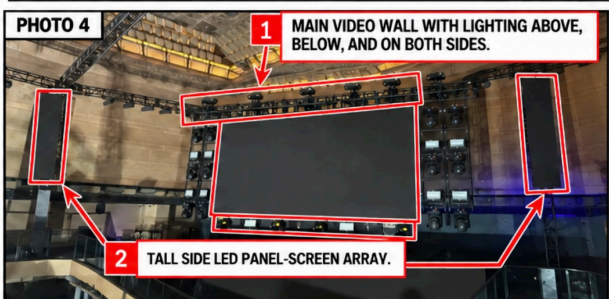
**5** CURRENT VIDEO-WALL/TRUSS CONFIGURATION REPLACED THE EARLIER SUSPENDED CURVED-SQUARE TRUSS SYSTEM SHOWN IN PRIOR RECORDS.

**PHOTO DOCUMENTATION OF LARGE DISPLAY AND LIGHTING LOADS WITHIN THE VERTICAL TRUSS SYSTEM. OWNER REPORTS NO BUILDING, INSTALLATION, PLAN-CHECK, OR ELECTRICAL PERMITS FOR THIS WORK.**

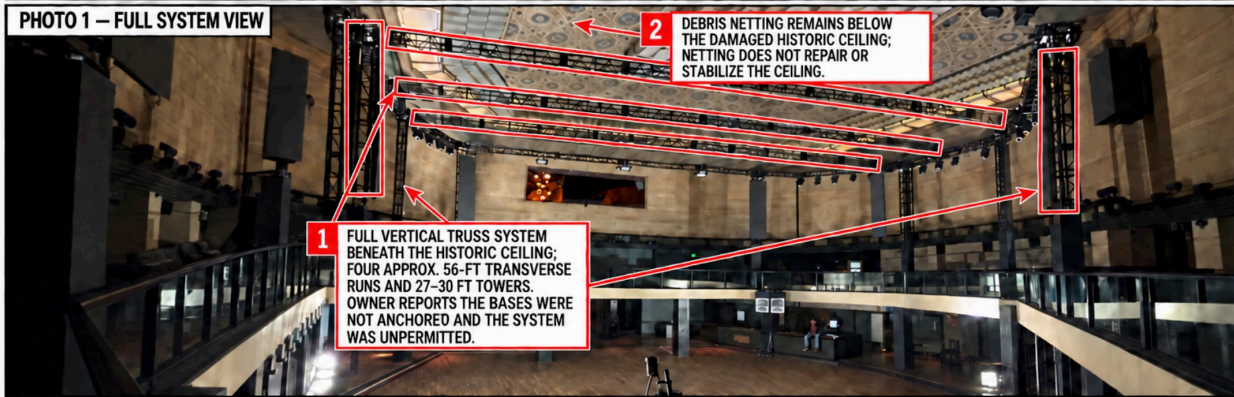
PHOTO 1 — FULL SYSTEM VIEW

DOCUMENTED CONDITIONS SHOW A CONCENTRATION OF CEILING PENETRATIONS AND RIGGING ACTIVITY OVER THE EAST/STAGE SIDE. OWNER REPORTS THE WORK WAS PERFORMED WITHOUT PERMITS.

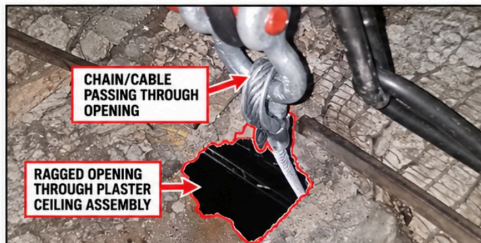
1 PLENUM-SIDE VIEW OF RAGGED OPENING THROUGH HISTORIC PLASTER CEILING ASSEMBLY.

HBS (MAY 13, 2024):  
APPROX. 20-40 HOLES, FROM ABOUT 4 INCHES TO MORE THAN 12 INCHES; PLASTER ON METAL-MESH LATH SUPPORTED BY THIN BLACK-IRON CHANNELS.

THESE PHOTOS DOCUMENT THE UPPER/PLENUM SIDE OF THE 97-YEAR-OLD DECORATIVE CEILING.  
OWNER REPORTS THE PENETRATIONS AND RIGGING WORK WERE UNPERMITTED.

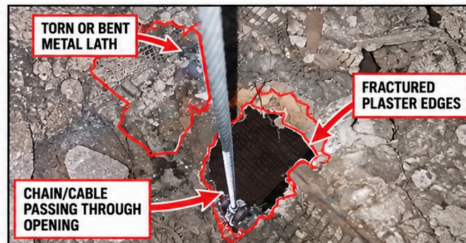
2 TORN OR BENT METAL LATH AND FRACTURED PLASTER AROUND RIGGING PENETRATION.

FICCADENTI (DEC. 18, 2024):  
SOME PENETRATIONS DAMAGED CEILING-SUPPORT WIRES, INCREASING FALLING-TILE RISK.

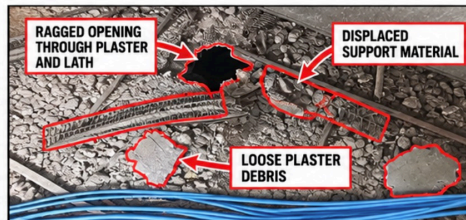
4 LOOSE PLASTER DEBRIS AND DISPLACED SUPPORT MATERIAL SURROUND THE OPENINGS.

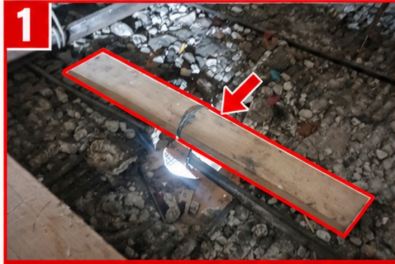
**MAKESHIFT LUMBER ACCESS OVER THE HISTORIC CEILING.**

RECORDED 2x6 LUMBER USED AS A MAKESHIFT CATWALK, PRECARIOUSLY BALANCED ON THE BLACK-IRON MATRIX, PLACING HISTORIC TILE AT DIRECT RISK.

RECORDED NEWER 2x LUMBER LAID ACROSS THE CEILING FOR WORKER ACCESS.

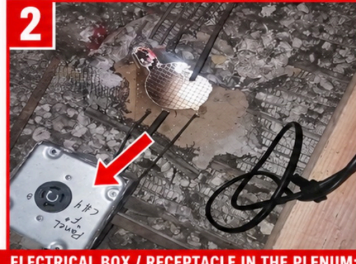
**ELECTRICAL BOX / RECEPTACLE IN THE PLENUM; OWNER REPORTS NO ELECTRICAL, PERMIT. PHASE CANNOT BE DETERMINED FROM THIS PHOTO.**

**THE EXTERIOR APPEARANCE OF A RECEPTACLE DOES NOT IDENTIFY SINGLE-PHASE OR THREE-PHASE SERVICE; CONDUCTORS, VOLTAGE, BREAKER, RECEPTACLE CONFIGURATION, AND EQUIPMENT NAMEPLATE ARE REQUIRED.**

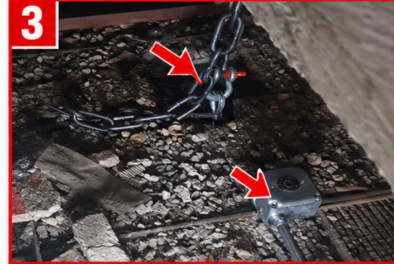
**ELECTRICAL CABLING, RIGGING HARDWARE, AND CEILING DEBRIS IN THE SAME PLENUM AREA.**

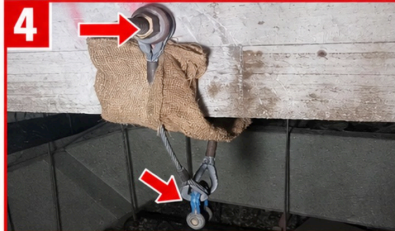
**THREADED CONCRETE-BEAM THROUGH-BOLTS AND WIRE-ROPE RIGGING CONNECTIONS.**
