## PHOTO EVIDENCE — FULL TRUSS SYSTEM AND EAST/STAGE-SIDE CEILING CONCENTRATION — PAGE 3 OF 5

## PHOTO EVIDENCE — PLENUM-SIDE CEILING PENETRATIONS AND DAMAGED LATH

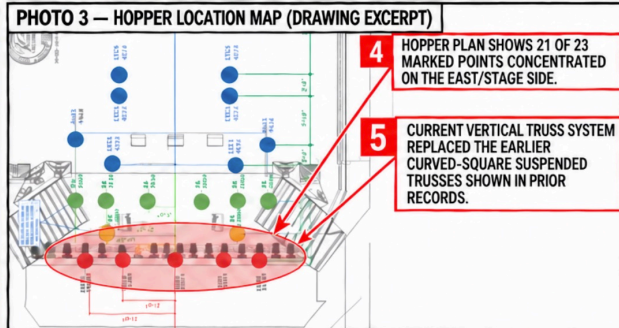
PHOTO 3 — HOPPER LOCATION MAP (DRAWING EXCERPT)

DOCUMENTED CONDITIONS SHOW A CONCENTRATION OF CEILING PENETRATIONS AND RIGGING ACTIVITY OVER THE EAST/STAGE SIDE. OWNER REPORTS THE WORK WAS PERFORMED WITHOUT PERMITS.
